LABORATORY EVALUATION OF A SHIPBOARD MULTIFUNCTIONAL WASTE INCI--ETC(U)  
OCT 79 F CROWSON, J A BYRNE, W W JONES

NSWC/TR-79-264

4. TITLE (and Subtitle) LABORATORY EVALUATION OF A SHIPBOARD MULTIFUNCTIONAL WASTE INCINERATOR (MFI). PHASE II	5. TYPE OF REPORT & PERIOD COVERED Final rept.	6. PERFORMING ORG. REPORT NUMBER

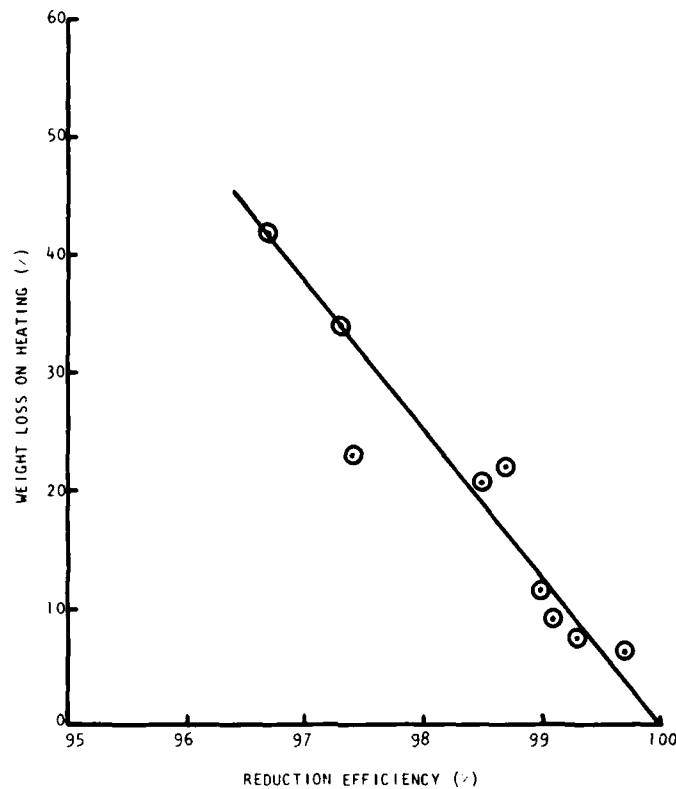
The experimental averages for WLOH and the percent reduction efficiency from Table 2 were plotted to give the correlation shown in Figure 3. From this relation, a value less than 2-percent WLOH would require an efficiency of 99.9 percent or better. The average efficiency for the MFI-II during the 1200-hr test was 98.1 percent. An increase in firebox temperature was considered as a solution to reducing the WLOH; however, during sewage tests, the firebox temperatures reached as high as 1950°F (550°F above the firebox set point) without producing the required WLOH. Based on the above considerations, the 2-percent WLOH criterion appears to be too stringent for the state-of-the-art design.

Figure 3. WLOH of MFI-II Ash vs Reduction Efficiency

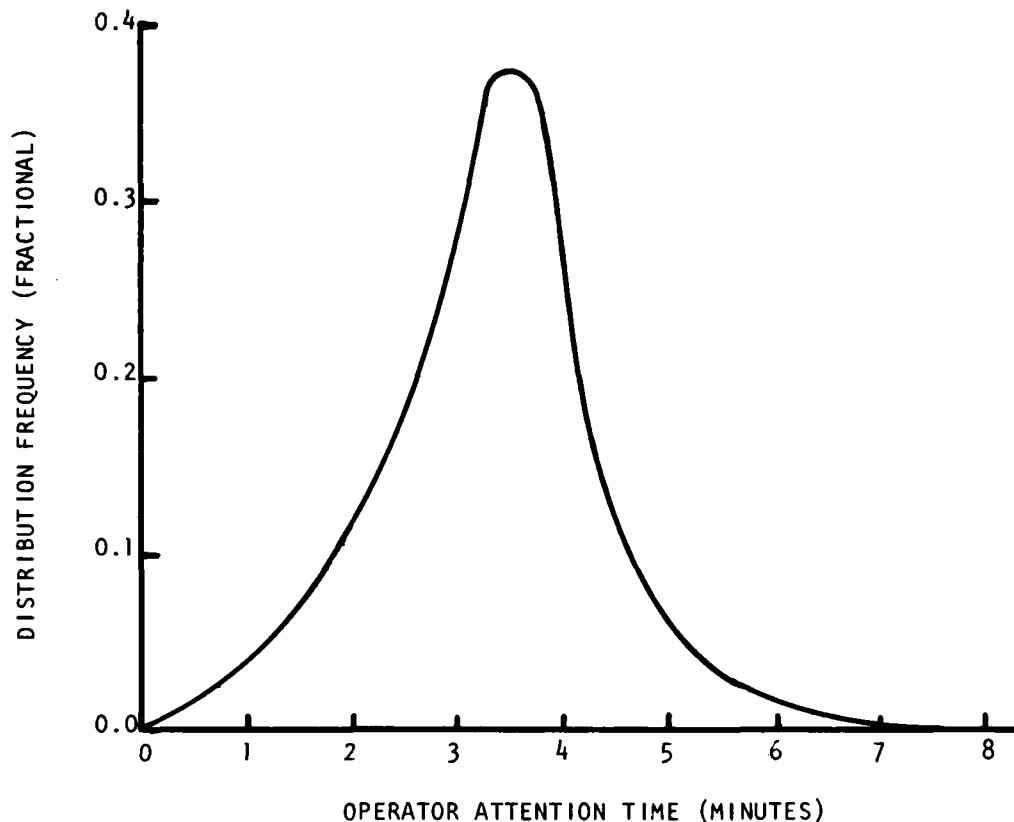
The operator attention time for the MFI-II is required not to exceed 5 min/hr. The average value for the entire 1200-hr test period was 3.4 min/hr, and the distribution for the operator attention time is shown in Figure 4. The requirement was exceeded 6 percent of the total test hours, primarily in the 4th and 5th hr of operation, during the first 37 tests and the last 10 tests. The excessive attention time was initially due to buildup of ashes and solid wastes (refuse or trash) in the firebox because of an improper setting on the ash door timer. The problem was alleviated by resetting the ash door timer, as per NAVSEC request, to allow the ash door to open on each full forward stroke of the ram. This action allowed ashes to be pushed from the firebox during each feed cycle, thereby reducing buildup. Operator attention time during the last 10 tests was increased because of increase in stoking as required to conduct the tests discussed earlier pertaining to the WLOH. Operator attention time was exceeded by only 1 percent during tests 38 through 140. Attention time during these tests was due to a series of isolated problems, such as initial debris behind the ram, one fire in the hopper that was cleared with a rake, and binding of the ram due to feed hopper warpage. Additionally, operator attention time during feeding is affected by low-density loose trash, which requires more feeds to process the required hourly weight of materials; however, this does not increase attention time beyond the 5-min/hr specification.

Figure 4. Distribution of Operator Attention Time

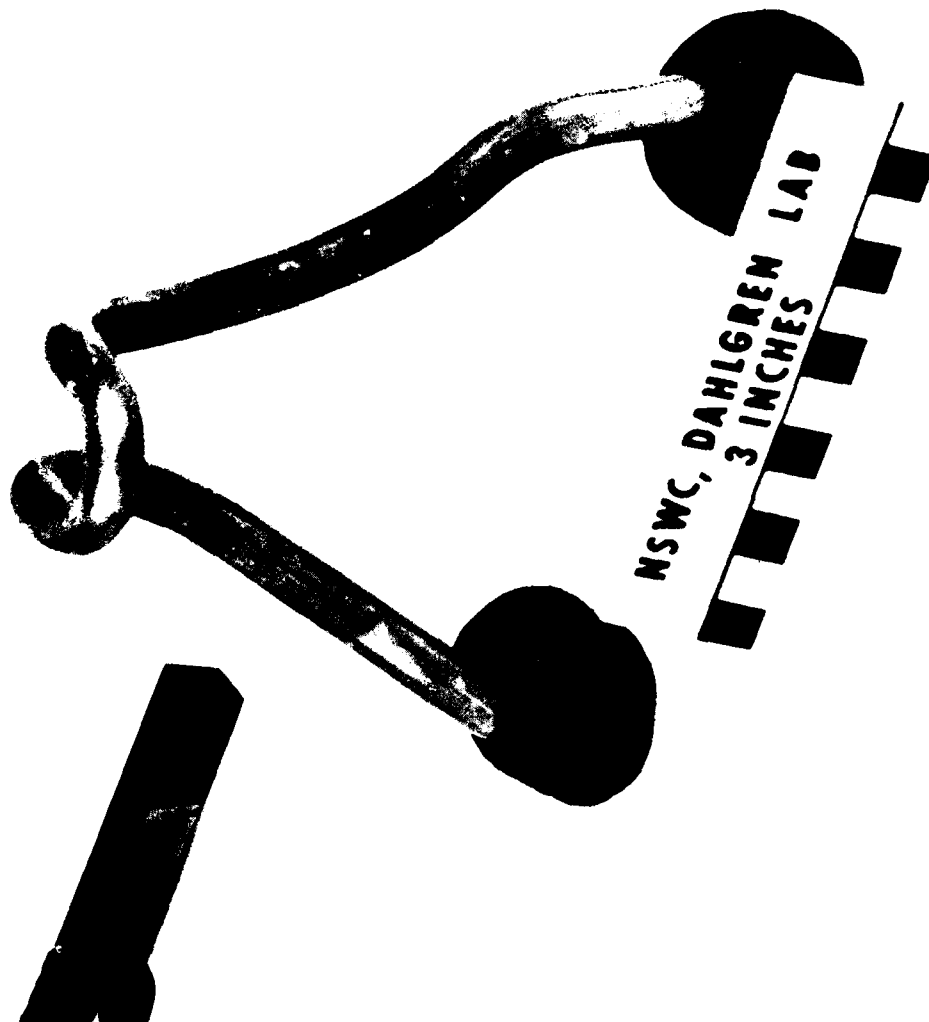
A redesign of the incinerator framework became necessary because of the vulnerability of the refractory to external vibrations and shock. The steel side panels were increased in thickness, and the refractory anchors were changed to sturdier S-shaped anchors (Figure 19) rather than the V-shaped anchors originally used to prevent movement of the refractory in any plane. Additionally, the anchors were bolted on all panels to facilitate future replacement of the refractory when necessary.

Figure 19. S-Shaped Refractory Anchors of MFI-II Unit

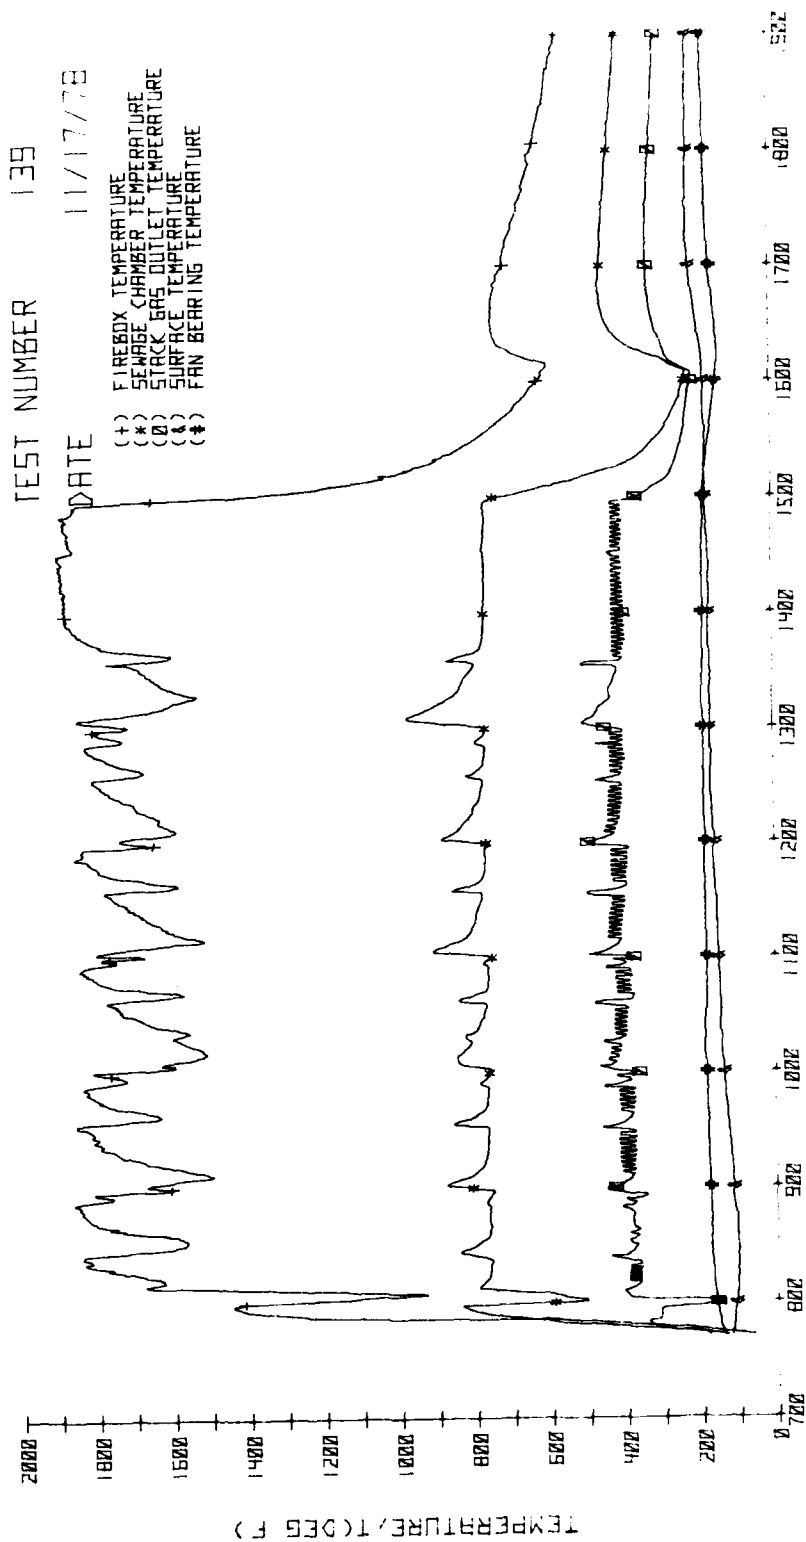
The MFI met the requirement for a flue exhaust temperature of less than 650°F. The maximum temperature recorded was 610°F without sewage and 570°F with sewage. The mean exhaust temperature was 485°F for the first 50 tests with no sewage and 461°F for the remaining 100 tests with sewage. Figure 30 illustrates temperature profiles during a typical test.

Figure 30. MFI Temperature Profiles

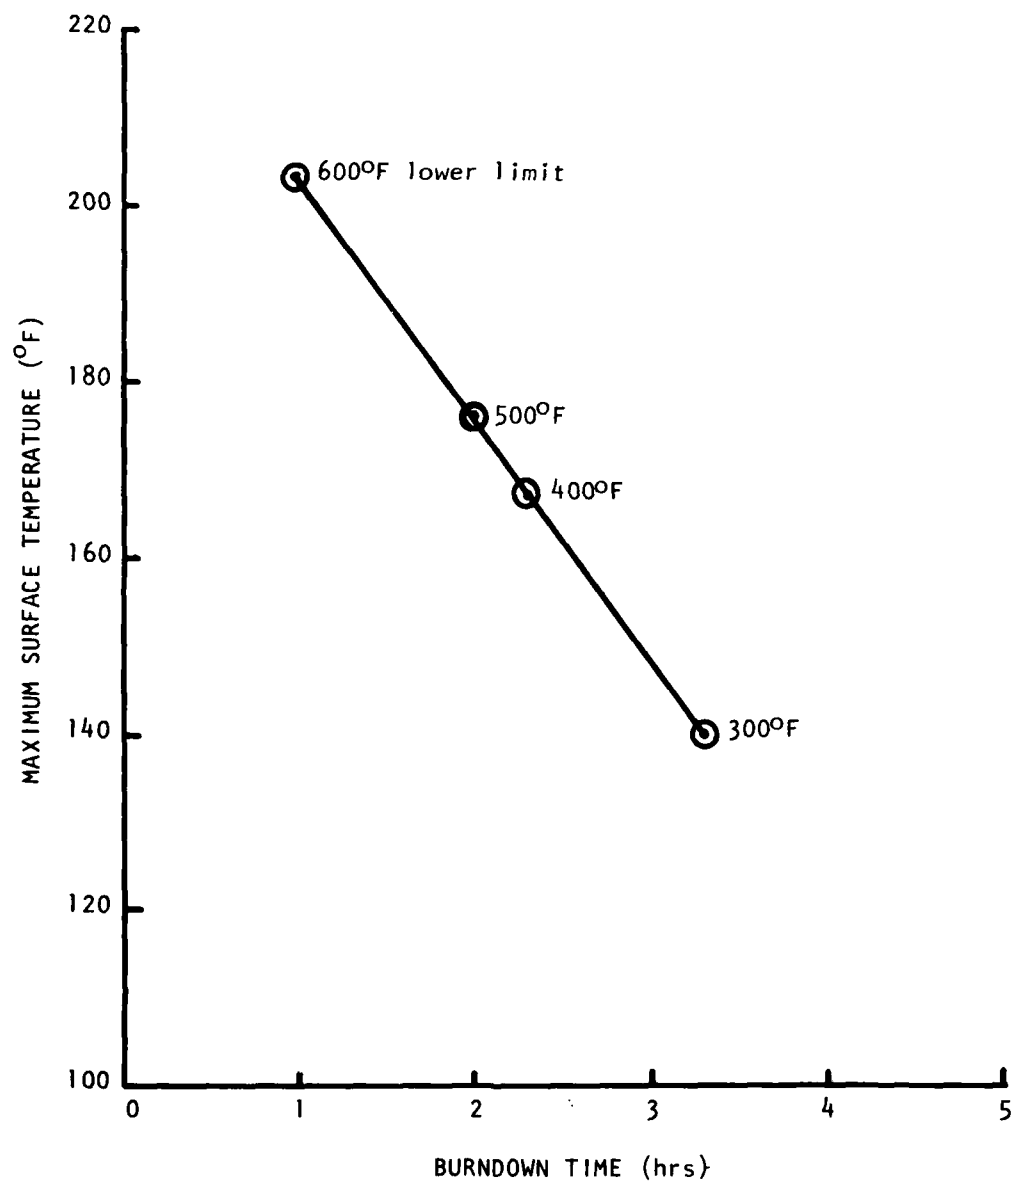
Other tests were conducted to determine the effect of a lower shutdown temperature setting on the firebox controller. As shown in Figure 31, reducing the surface temperature below the 140°F specification required a burndown period of 3.3 hr. If this extended burndown time is considered unacceptable, the increase of insulation thickness on the cooling jacket interior wall is the most likely alternative.

Figure 31. Surface Temperatures vs Burndown for Various Shutdown Limits
